# Manhole Inspection Summary

Manhole # S31AA\_047MH

**Location** Address: **718 MLK JR BLVD** Cross Street: **MCCULLOH ST**

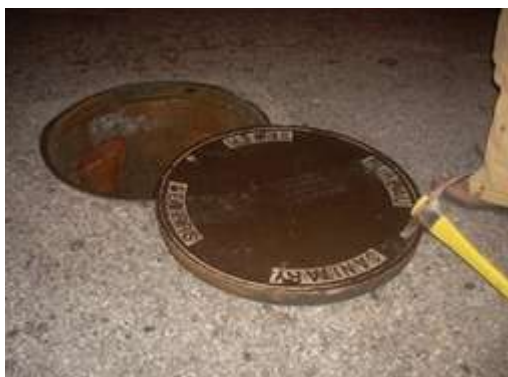
Defect 1

**Cover** Shape: **Circular** Diameter: **30** (in.) Length: (in.) Dist A/B Grade: **0** (in.)  
Type: **Sanitary** Condition: **Worn** Cover Material: **Cast Iron**  
Properties: ☐ Bolted ☐ Vented ☐ Water Tight ☐ Water Tight Insert

WORN COVER

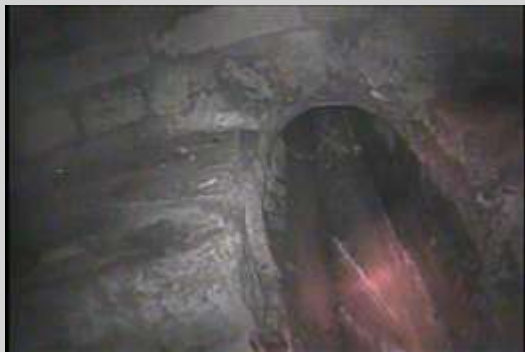
12 O'Clock Outflow

8 in. Circular Gravity Sewer  
Pipe Out @ 12 O'Clock

Pipe Height: **8.4** (in.) Rod and Bar (Angled)  
Pipe Material: **Clay** ☐ Pipe Lined  
Invert Depth: **10.70** (ft.) Flow Characteristics: **Slow**  
Deposits: ☒ None ☐ Mud ☐ Sludge ☐ Debris ☐ Grease  
Silt Depth: (in.) Deposits Extent:  
Infiltration: **None** Pipe Seal Cond: **Sound**

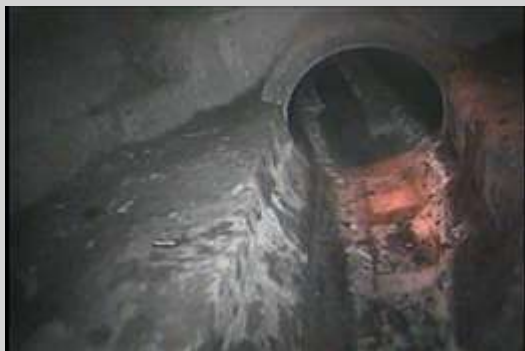
4 O'Clock Inflow

8 in. Circular Gravity Sewer  
Pipe In @ 4 O'Clock

Pipe Height: **7.2** (in.) Rod and Bar (Angled)  
Pipe Material: **Clay** ☐ Pipe Lined  
Invert Depth: **10.37** (ft.) Flow Characteristics: **Slow**  
Deposits: ☒ None ☐ Mud ☐ Sludge ☐ Debris ☐ Grease  
Silt Depth: (in.) Deposits Extent:  
Infiltration: **None** Pipe Seal Cond: **Sound**

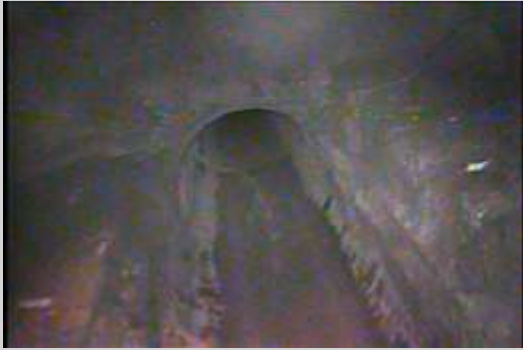
6 O'Clock Inflow

Pipe Height: **8.4** (in.) Rod and Bar (Angled)

Invert Depth: **10.57** (ft.) Flow Characteristics: **Slow**

Infiltration: **None** Pipe Seal Cond: **Sound**

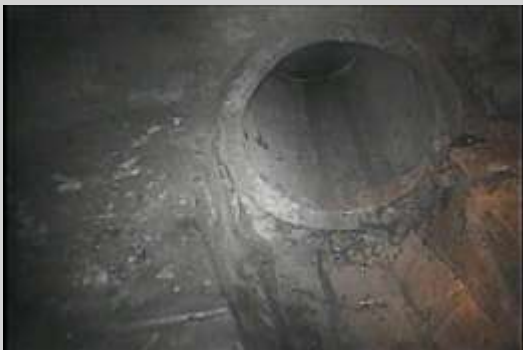
9 O'Clock Inflow

Pipe Height: **8.4** (in.) Rod and Bar (Angled)

Invert Depth: **10.10** (ft.) Flow Characteristics: **Slow**

Infiltration: **None** Pipe Seal Cond: **Sound**
